MAINTENANCE OF THE STEAM TURBINES AT HELLISHEIÐI POWER PLANT

Maintenance of the steam turbines at Hellisheiði power plant

30 ECTS thesis submitted in partial fulfillment of a
Magister Scientiarum degree in Mechanical engineering

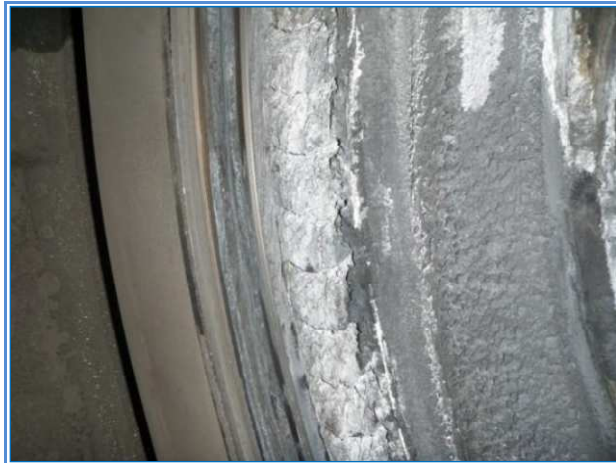
Figure 4.3 Silica scaling on the first stage diaphragm in turbine 3 at Hellisheiði power plant [41].

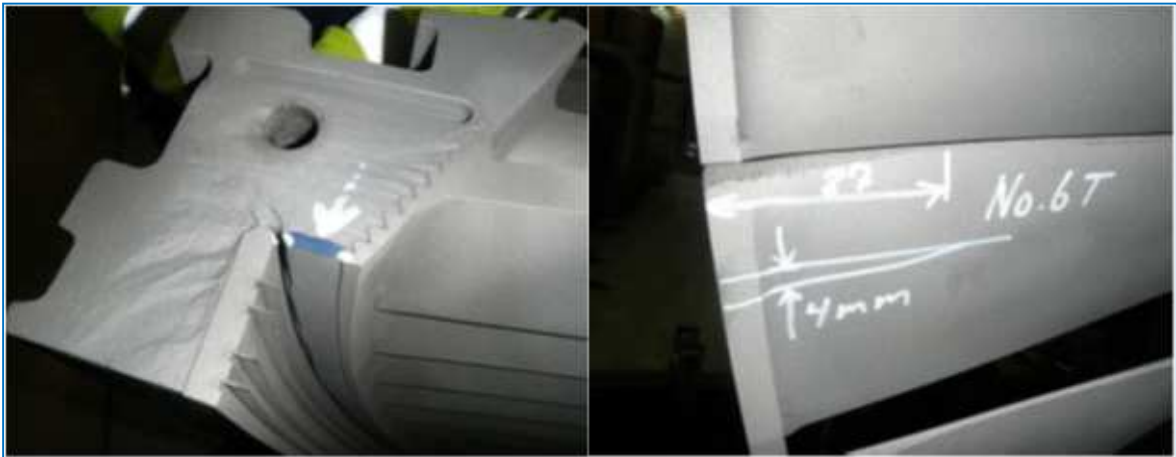
Figure 4.4 Both pictures are from turbine 3 at Hellisheiði power plant. Left, wear due to erosion on the horizontal joint on the fourth stage diaphragm. Right, wear due to erosion on the leading edge and the back face of the leading edge at the tip of a rotor blade at stage six [41].

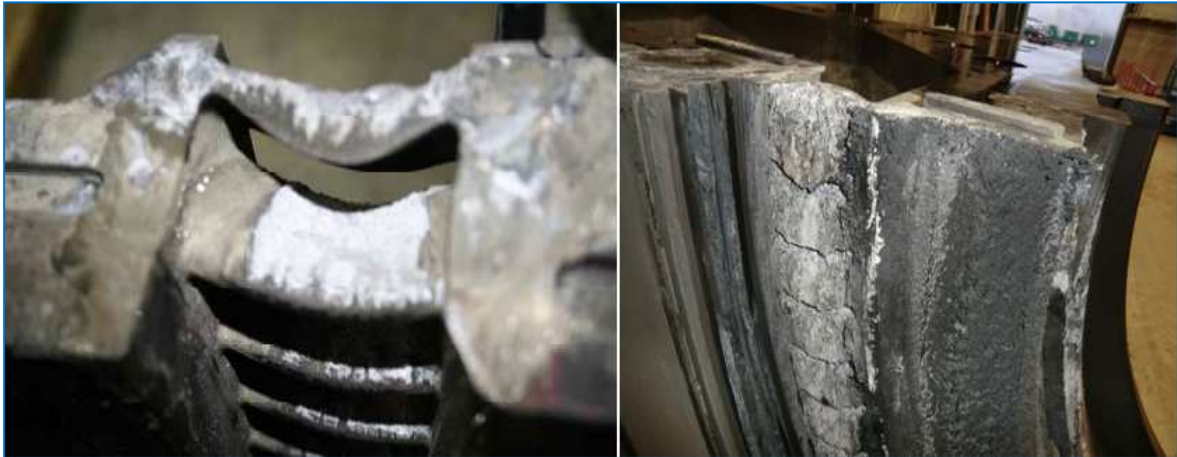
Scaling is not a serious problem at Hellisheiði power plant and is generally found in a small amount on the stator blades, mainly, though, on the first stage diaphragms. Turbine 3 has, however, suffered from considerable scaling problems that caused performance drop and hastened the overhaul of the turbine. Scaling was found on the stator blades through the whole turbine, the greatest amount being found on the stator blades in the first stage diaphragms. An example of scaling can be seen in Figure 4.6. XRD and SEM analyses of the scaling in turbine 3 measured mainly quartz, metal sulfide, sodium chloride and zeolithe. The maintenance staff at Hellisheiði power plant believes that well 45, which is a relatively dry well, is responsible for this scaling. In order to prevent further scaling problems in the future, water injection has been started at the wellhead on well 45. The result from that process is promising.

Figure 4.6 *Left, scaling on the first stage stator blades in turbine 2 at Hellisheiði power plant. Right, scaling on the first stage stator blades in turbine 3 at Hellisheiði power plant [41].*

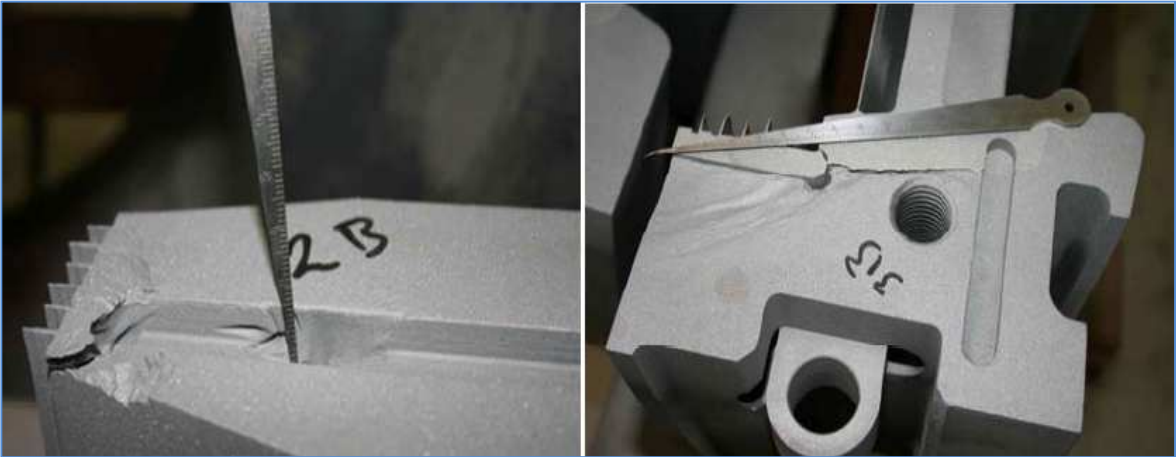
Figure 4.7 Left, erosion damage on the horizontal joint on the second stage diaphragm in turbine 2 at Hellisheiði power plant. Right, erosion damage on the horizontal joint on the third stage diaphragm in turbine 3 at Hellisheiði power plant [41].

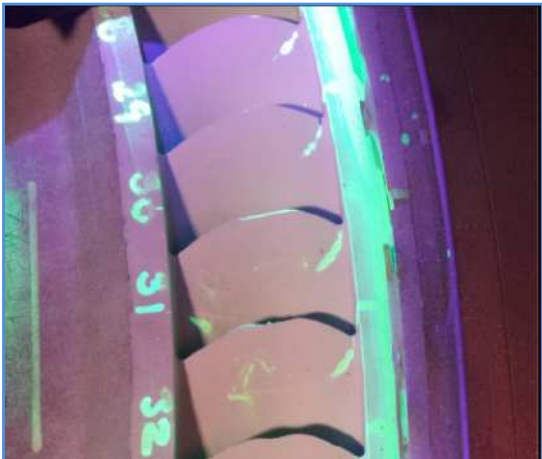
stage diaphragm in turbine 3 is the only one, which has been examined especially for cracks. It is thus possible that diaphragms in other turbines could have small cracks, which cannot be found with visual inspection.

Figure 4.8 Cracks at the backsides of the stator blades on the first stage diaphragm in turbine 3 at Hellisheiði power plant [41].

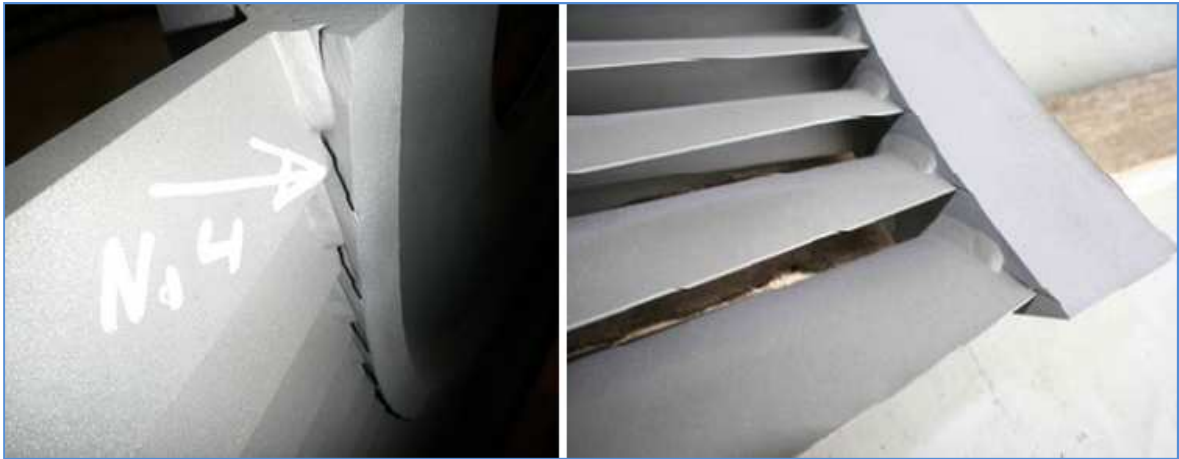
Figure 4.9. This wear is most likely caused by a combination of solid particle and water droplet erosion and possible erosion corrosion. Solid particle erosion is, though, probably the dominating mechanism because there is less damage at stages 5 and 6 where there is more moisture in the steam. Different design of the stator blades roots at the first three stages can explain why they do not suffer from this wear. The roots at the first three stages along with the outer one at stage four are also made of stainless steel, while carbon steel is used at the other stages. This difference can be seen in Figure 4.10. This damage did, however, not occur in the low pressure turbine. This can be explained with the construction of the hoops where the stator blades are attached to the diaphragms there as they are made of stainless steel.

Figure 4.9 Left, wear at the inner roots of the stator blades at stage four in turbine 3 at Hellisheiði power plant. Right, wear at the inner roots of the stator blades at stage five in turbine 2 at Hellisheiði power plant [41].

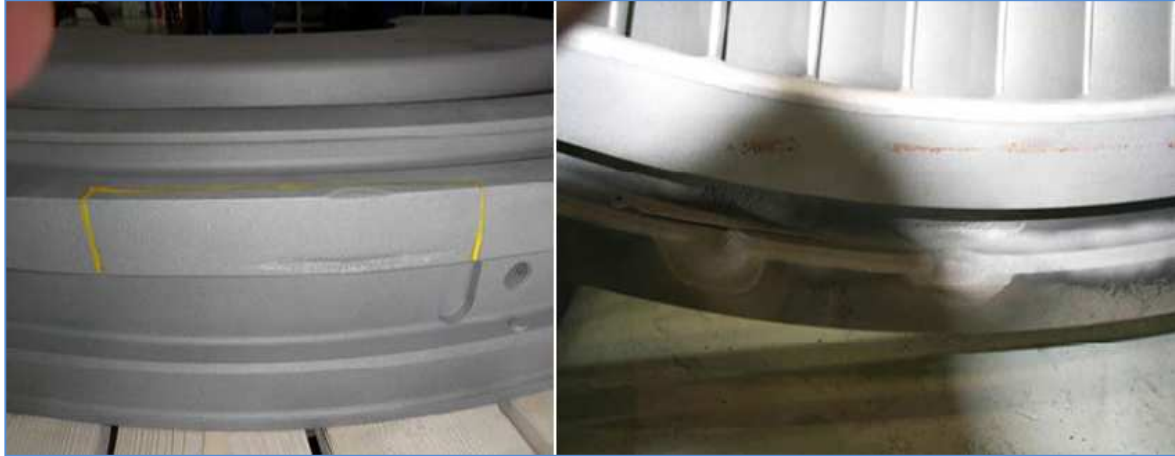
Wear at the side of the diaphragms is also a problem. This wear is only found on the sides of the diaphragms above and behind the drains holes in the casing. It is therefore most likely caused by water droplet erosion. An example of this can be seen in Figure 4.11. This damage is not found in the low pressure turbine. Different design of the drain system there could explain that.

Figure 4.11 Both pictures are from turbine 2 at Hellisheiði power plant. Left, wear on the side and on the bottom of the third stage diaphragm. Right, wear at the side of the fourth stage diaphragm [41].

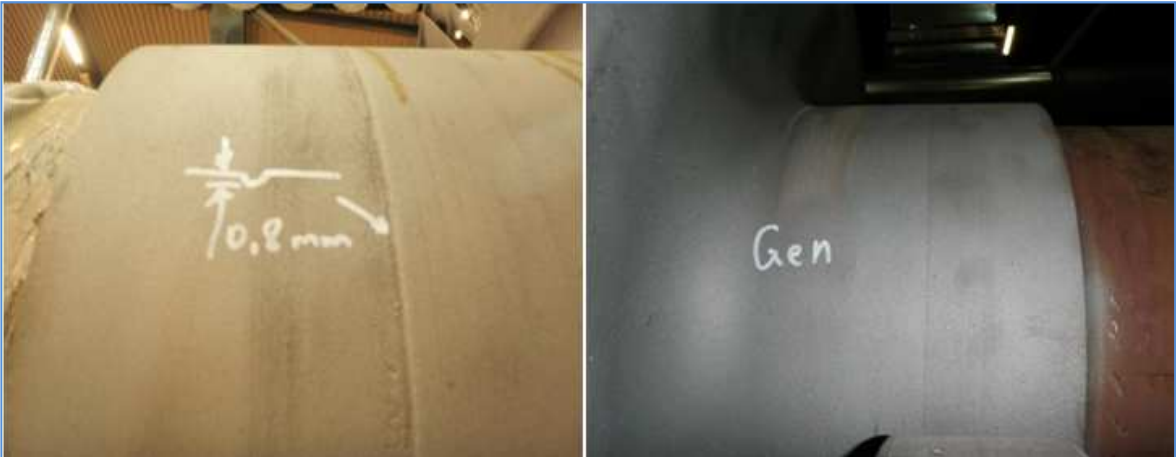
solid particle erosion. There are mainly two reasons, which support this. The wear is at the rotor but water droplets are normally found outwards in turbines as is described in the Erosion section in Chapter 4.2. The steam is also relatively dry at the first stages. Furthermore, labyrinth seals have feasible conditions for erosion as already explained in the Diaphragms section in Chapter 4.4. An example of this wear can be seen in Figure 4.14. The wear in the rotor labyrinth seals has to be monitored carefully because there is nothing that slows down the steam before it hits the rotor drums when the labyrinth fins have been worn down. This would result in a high erosion rate at the rotor drums, which would be both difficult and expensive to repair and could have severe effects.

Figure 4.13 Both pictures are from turbine 3 at Hellisheiði power plant. Left, wear of the low pressure seal surface. Right, the high pressure seal surface, which has almost no wear [41].

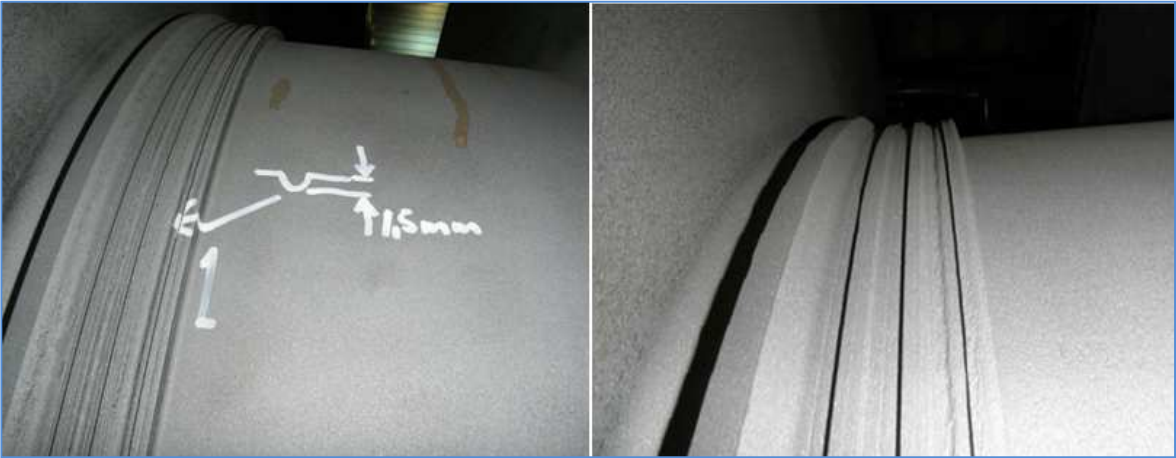
Figure 4.14 Left, 1.5mm wear of the rotor labyrinth seal for diaphragm two in turbine 3 at Hellisheiði power plant. Right, about 1mm wear of the rotor labyrinth seal for diaphragm two in turbine 2 at Hellisheiði power plant [41].

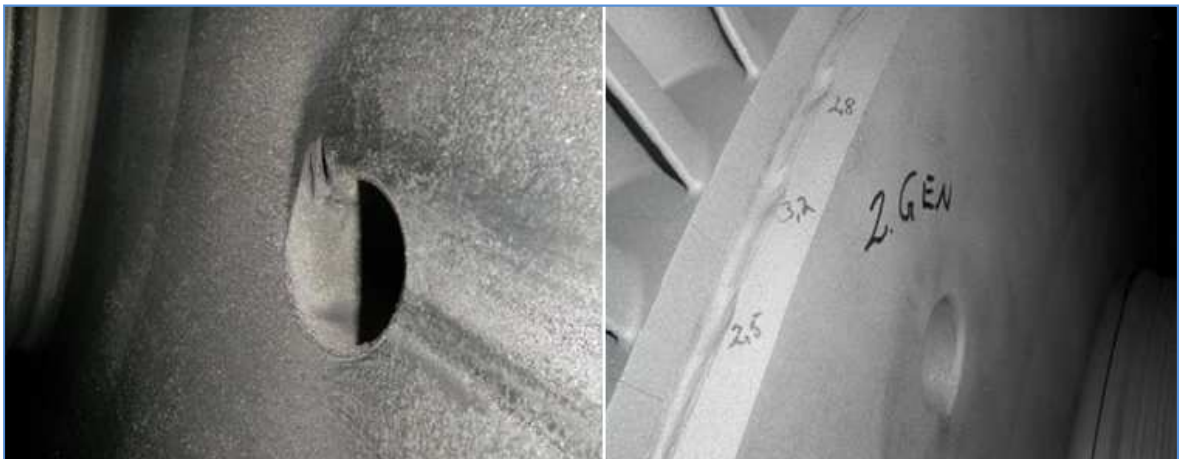
Figure 4.15 Left, wear of a steam balance hole at stage 3 in turbine 1 at Hellisheiði power plant. Right, wear at the backside of the rotor drum, beside the rotor blades roots at stage 2 in turbine 2 at Hellisheiði power plant [41].

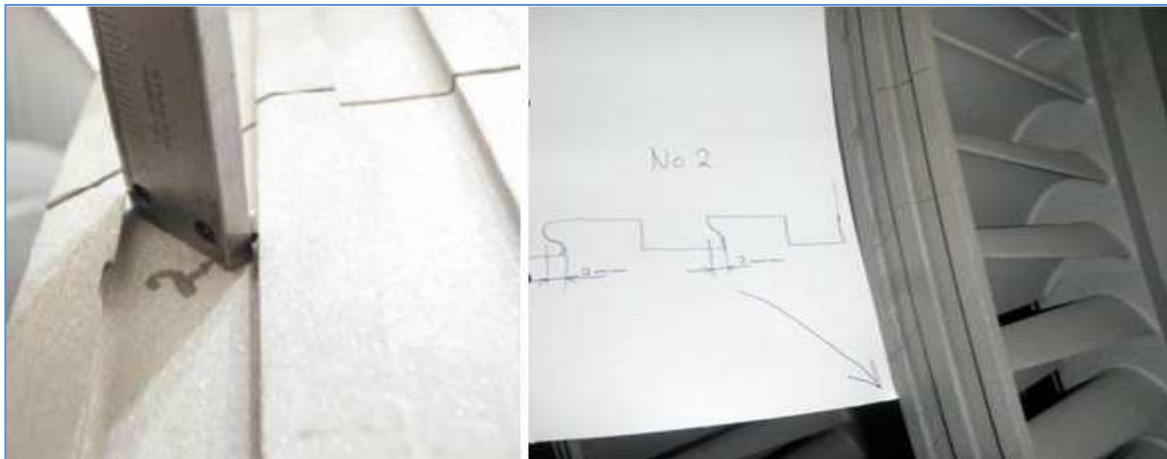
Figure 4.16 Both pictures show wear of labyrinth seals on the top of the rotor blades in the turbines at Hellisheiði power plant. Left, the second stage in turbine 2. Right, the second stage in turbine 3 [41].

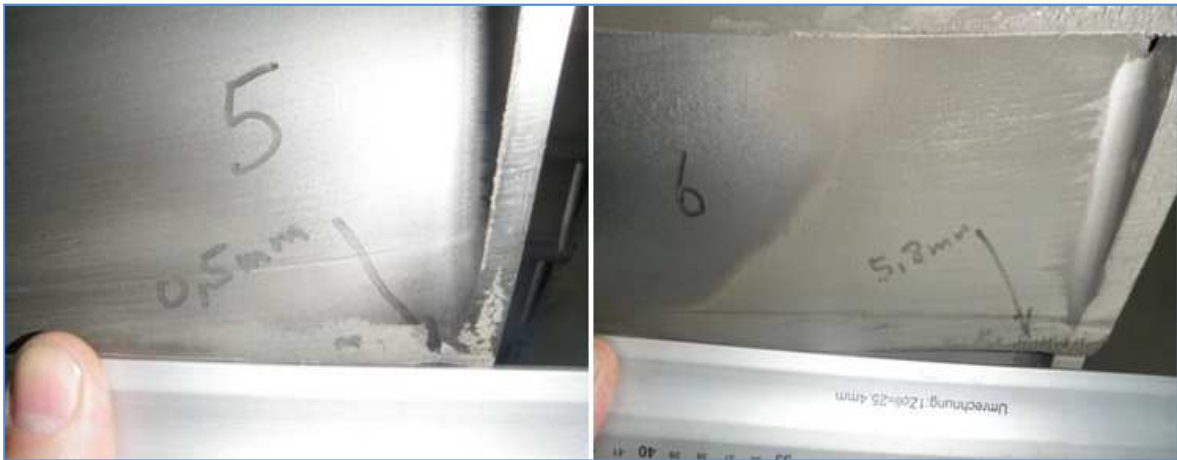
Figure 4.17 Both pictures are from turbine 1 at Hellisheiði power plant. Left, material deterioration at a fifth stage rotor blade. Right, material deterioration at a sixth stage rotor blade [41].

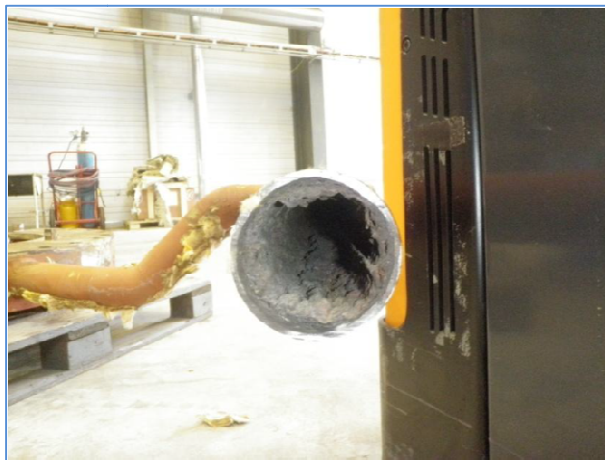
Figure 4.18 *Scaling in the pipe, which transports the steam from the high pressure gland seal to a condenser, for the low pressure turbine manufactured by Toshiba at Hellisheiði power plant [41].*

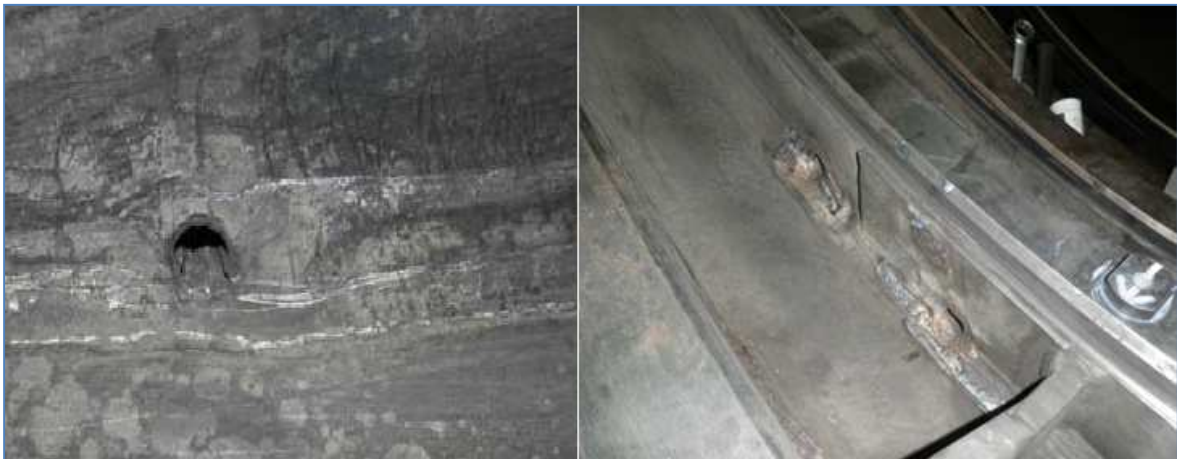
Figure 4.19 Left, wear of a drain hole at the third stage in turbine 2 at Hellisheiði power plant. Right, wear of drain holes in turbine 3 at Hellisheiði power plant [41].

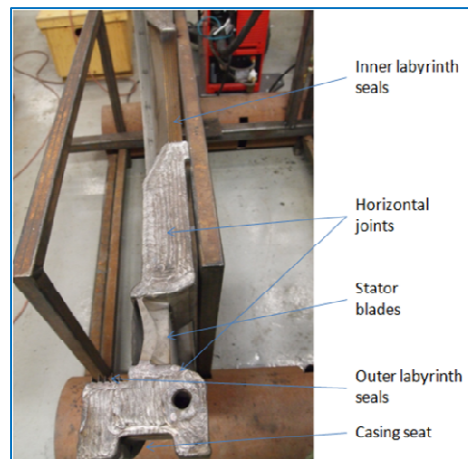
Figure 4.21 The first stage diaphragm from turbine 3 at Hellisheiði power plant after welding. The horizontal joint still has to be milled down to the original height and shape.

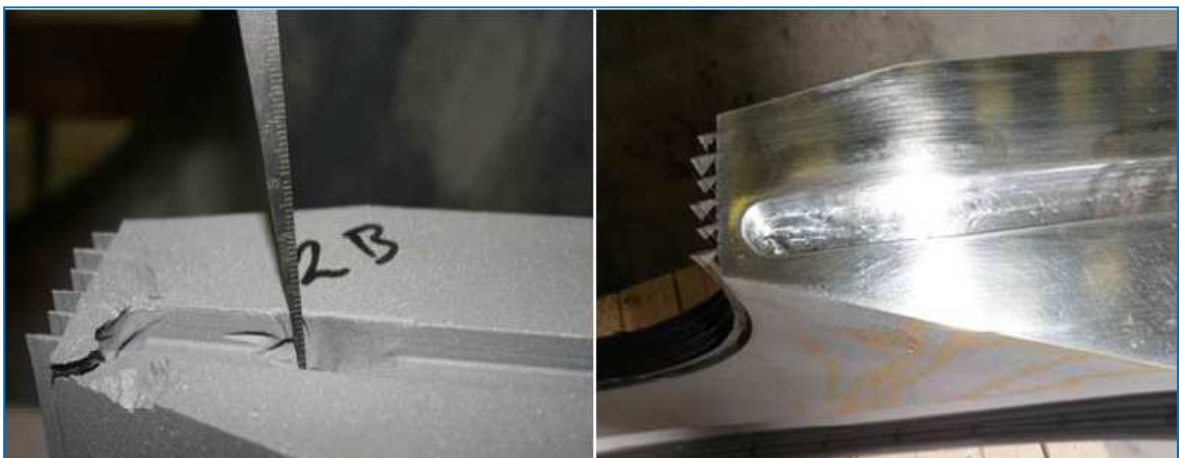
Figure 4.22 Both pictures are of the horizontal joint on the second stage diaphragm in turbine two at Hellisheiði power plant. Left, the horizontal joint before repair. Right, the horizontal joint after repair [41].

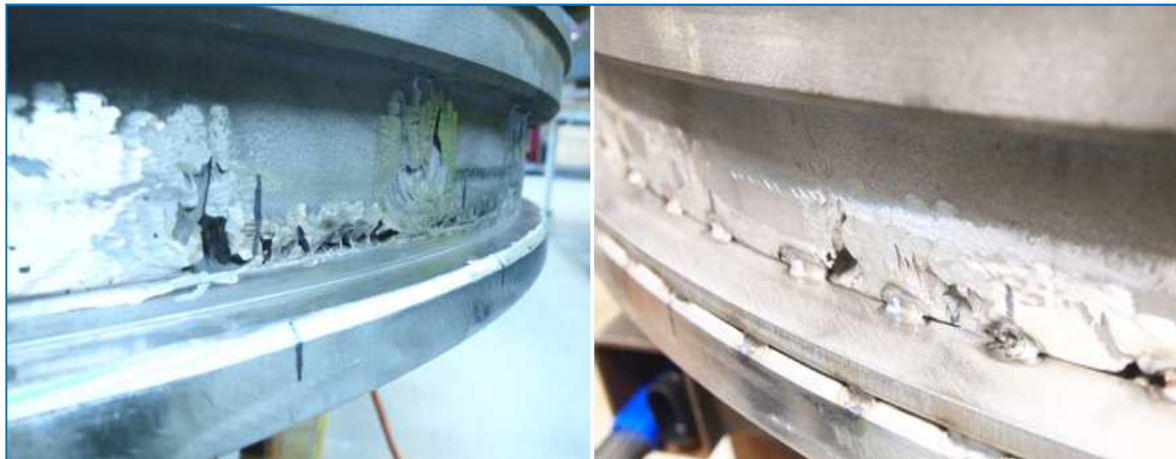
Figure 4.23 Both pictures are of a diaphragm from a steam turbine at Nesjavellir power plant. Left, wear in a casing seat, the side of the seat has been milled down. Right, here a piece of stainless steel is being welded over the side of the casing seat.

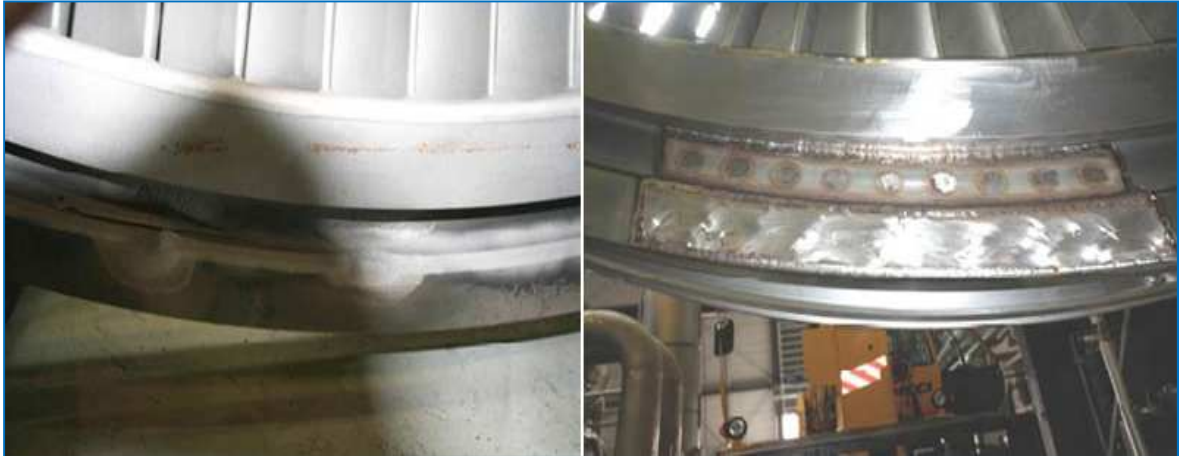
Figure 4.24 Left, the fourth stage diaphragm from turbine 2 at Hellisheiði power plant. Right, new diaphragm for the fourth stage in turbine 2 at Hellisheiði power plant with a shield to prevent erosion damage [41].

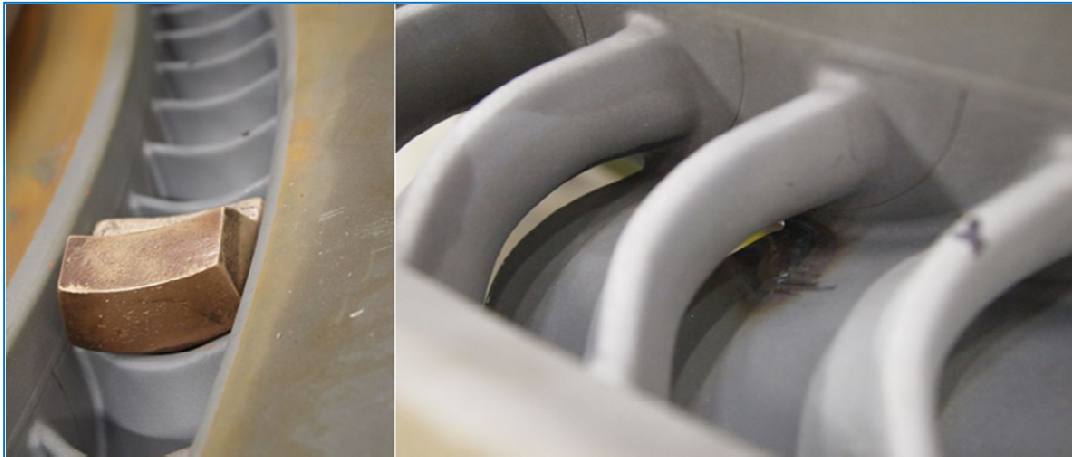
Figure 4.25 *Left, cooling element to cool stator blades on a diaphragm during welding. Right, the stator blades on the first stage diaphragm in turbine 3 at Hellisheiði power plant after welding.*

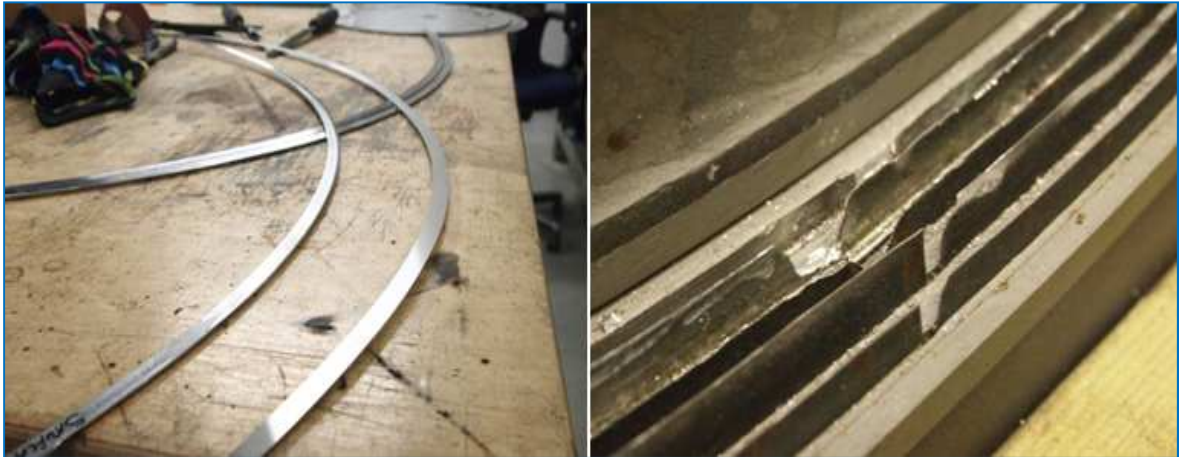
Figure 4.27 Left, labyrinth fins made on-site at Hellisheiði power plant. Right, worn outer labyrinth fins on a diaphragm from a steam turbine at Hellisheiði power plant.

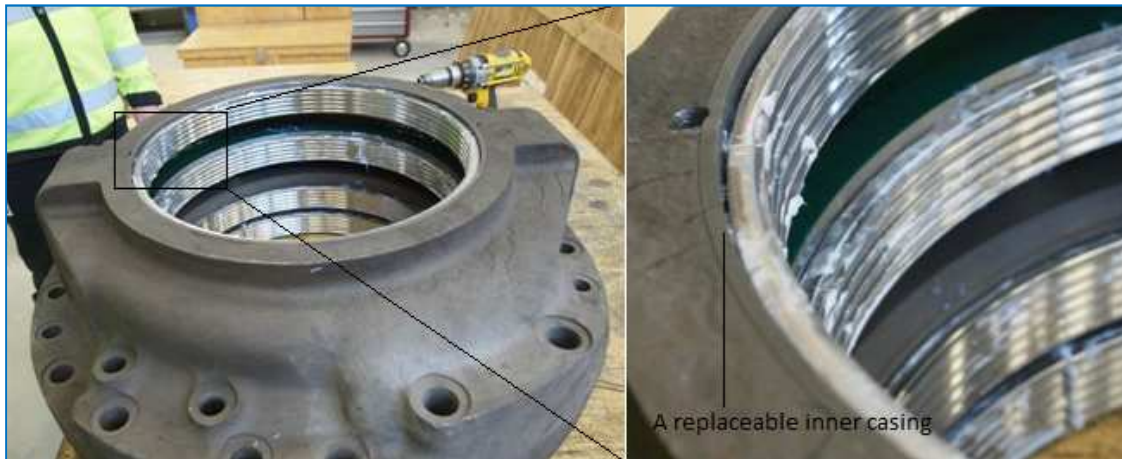
Figure 4.29 Left, repaired casing with new labyrinth packing made by Vélvík and a new replaceable inner casing made by Framtak. Right, an enlarged view of the new inner casing.

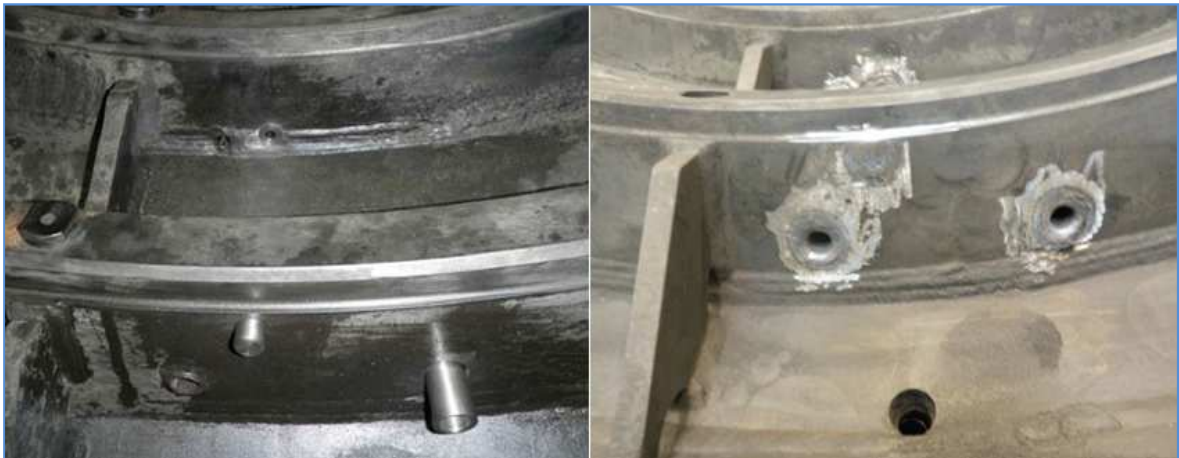
Figure 4.31 Left, drain holes in a diaphragm attachment in turbine two at Hellisheiði power plant with stainless steel cylinders fitted in. Right, drain holes in a diaphragm attachment in turbine one at Hellisheiði power plant after being repaired with stainless steel cylinders [41].

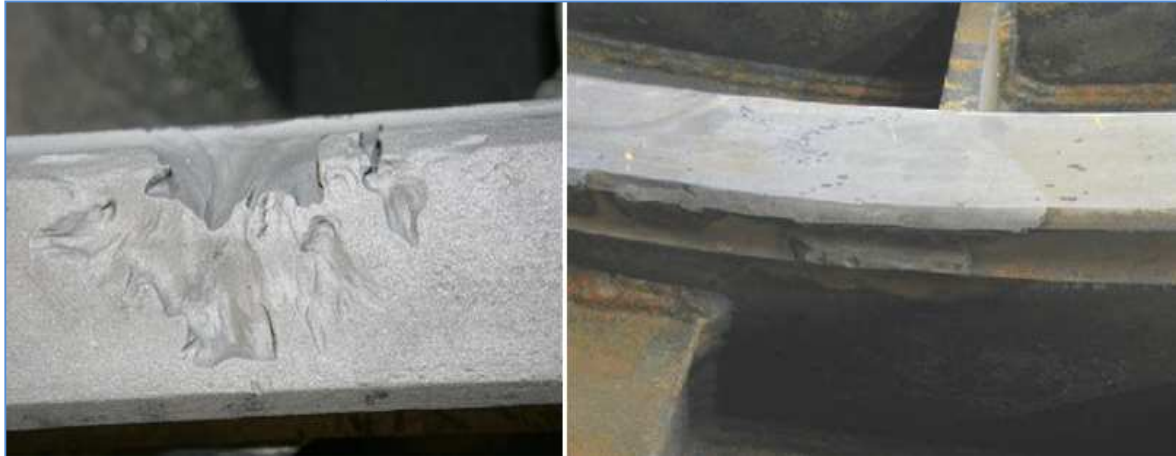
Figure 4.32 *Left, wear at the diaphragm attachment in turbine two at Nesjavellir power plant. Right, diaphragm attachment in turbine two at Nesjavellir power plant after welding and polishing [41].*
