Corrosion Testing in a Simulated High Temperature Geothermal Environment

Sigrún Nanna Karlsdóttir¹, Tindur Jónsson¹, Andri Stefánsson²

University of Iceland

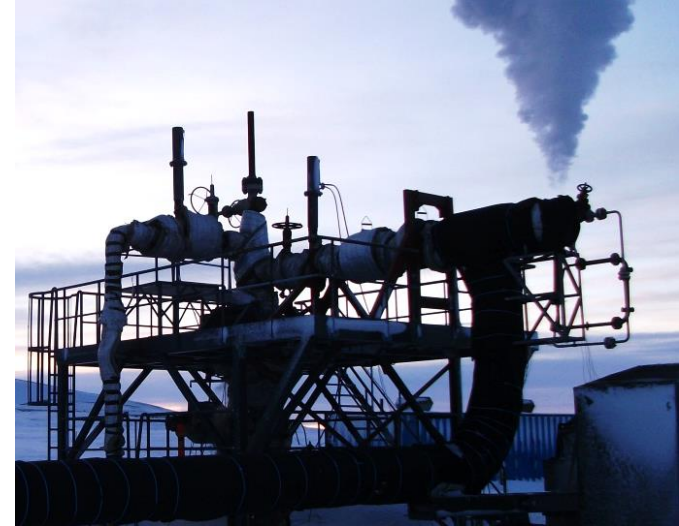
- IDDP-1 pilot tests on-site
 - **450°C and 140 bar at wellhead**
 - **Steam contains HCl, HF, H₂S, CO₂**
 - **pH ≈ 3**
 - **Dissolved silica and silica particles**
- To evaluate the possibility of utilizing the **superheated steam** from the IDDP-1 well
 - **Wet-scrubbing of the steam**
 - **Erosion-Corrosion Testing** ($T \approx 350^\circ\text{C}$, 12-13bar, 2-21 days)
 - **Heat Exchanger Experiment** ($T_{inlet} = 330-370^\circ\text{C}$, $T_{outlet} = 270^\circ\text{C}$, $P \approx 60$ bar, 2-24 days)
 - **Corrosion Testing in Flow line** ($T \approx 350^\circ\text{C}$, $P = 12-13$ bar, 113 days)

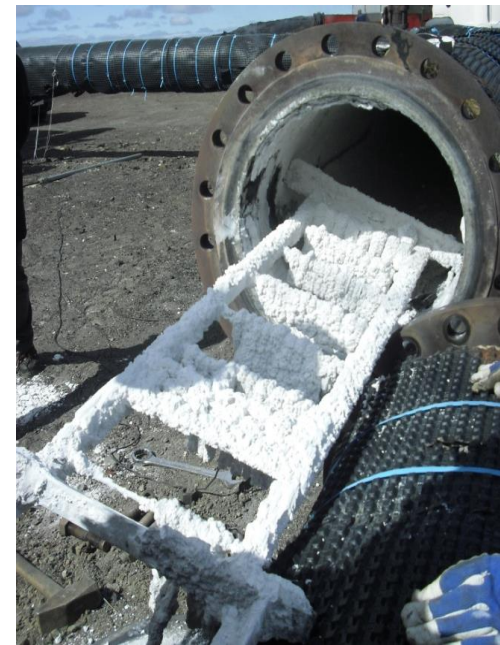
- **Very low corrosion rates** but small localized corrosion damages
 - narrow cracks and pits in even the most corrosion resistant alloys
- **Large amount of silica scaling** covered the test samples and clogged pipes
- Stress Corrosion Cracking (SCC) of **254 SMO** in heat-exchanger experiment
- **SCC** of low alloyed stainless steel (**304&316**)
- Overall best performance **Ni alloy 625** and **Titanium alloys**

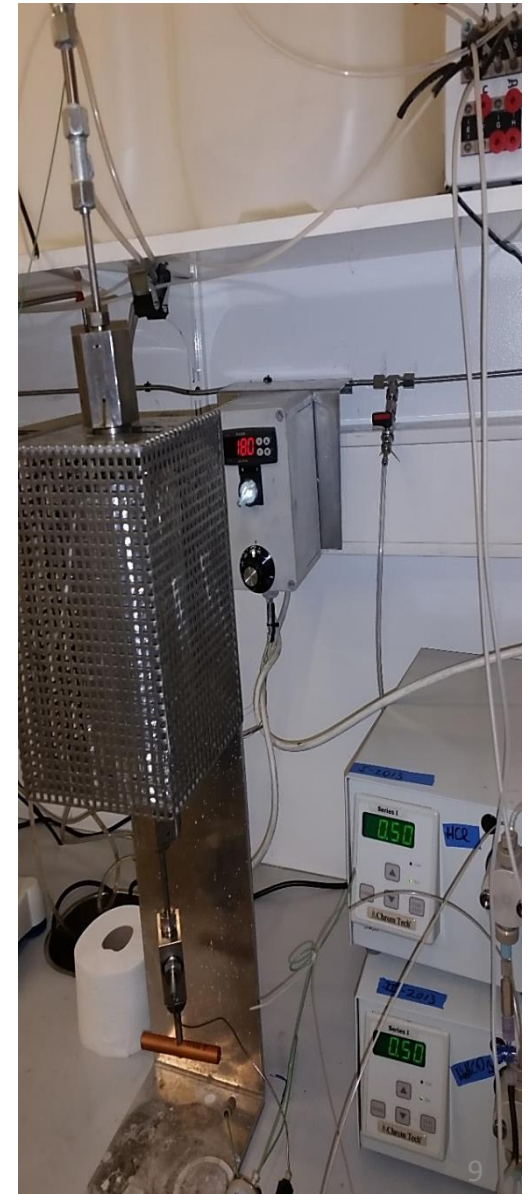
- Testing was done in 3 flow through reactors
- Backpressure valves maintained fixed pressure
- Digital heating elements to maintain temperature
- Piston pumps to circulate test solutions

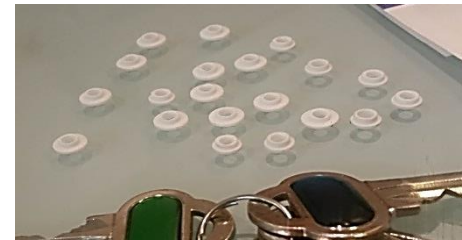
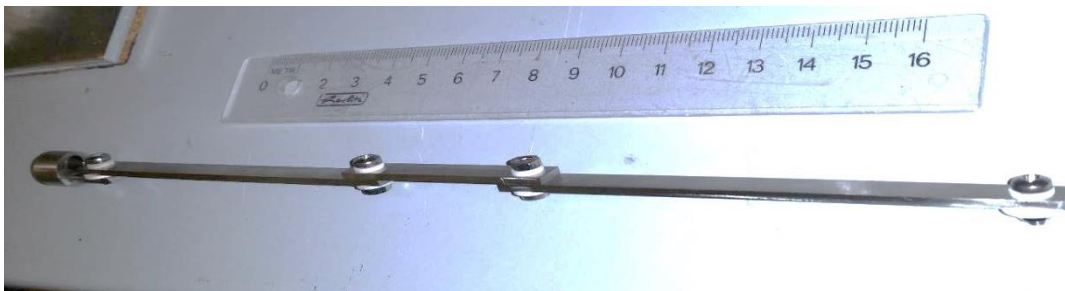
- Custom samples were used due to small reactor size ID=11.7mm
- Ceramic isolation washers were not available and were machined from MACOR
- Sample size was 100x7 and 50x7, t = 2 or 1.5 mm

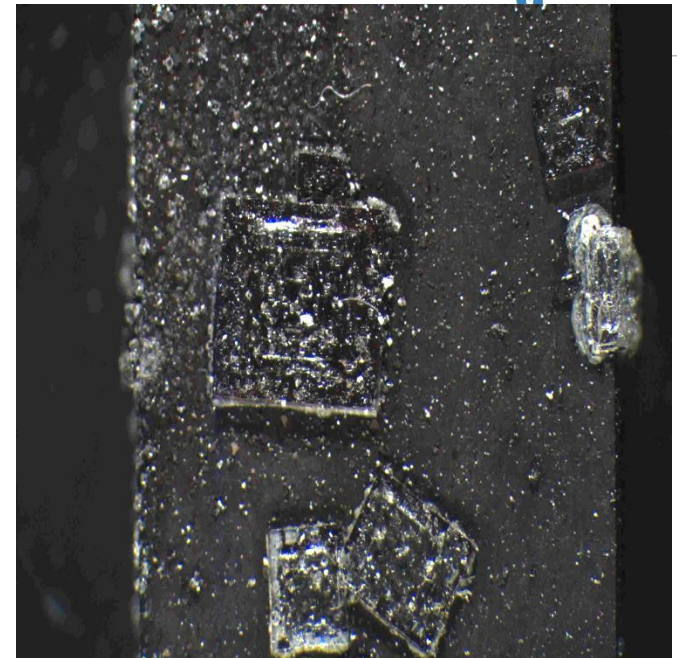
254 SMO

- CR for 1 week test 0.02 mm/yr
- CR for 3 week test 0.24 mm/yr
- Little damage on 1 week test
- NaCl crystals on samples for both tests
- Cracking seen after 3 weeks and acid corrosion damages

EHT = 20.00 kV WD = 8.5 mm Signal A = SE2 Mag = 1.00 K X
d8_09.tif 100 µm Date :21 Jul 2015
