MAINTENANCE OF THE STEAM TURBINES AT HELLISHEIÐI POWER PLANT

Maintenance of the steam turbines at Hellisheiði power plant

30 ECTS thesis submitted in partial fulfillment of a
Magister Scientiarum degree in Mechanical engineering

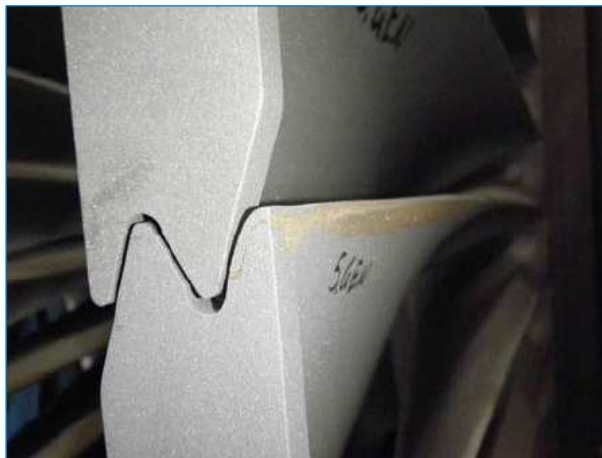
Figure 4.2 The tip of the integral shroud blades at stage five in steam turbine 2 at Hellisheiði power plant [41].

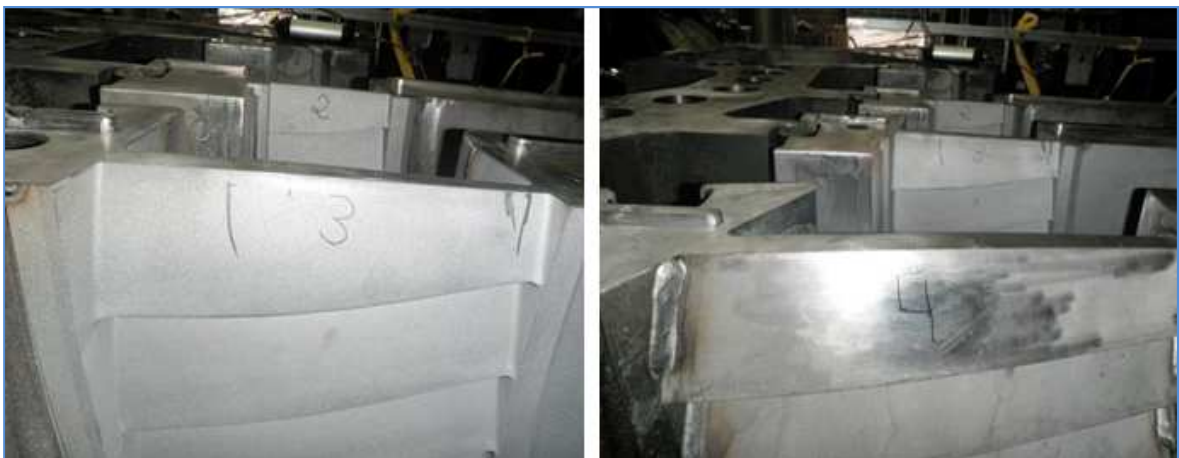
Figure 4.10 Both pictures are from turbine 3 at Hellisheiði power plant. Left, an example of the design of the inner and outer roots at the stator blades at stages 1-3 can be seen. Right, an example of the design of the inner and outer roots of the stator blades at stages 4-6 [41].

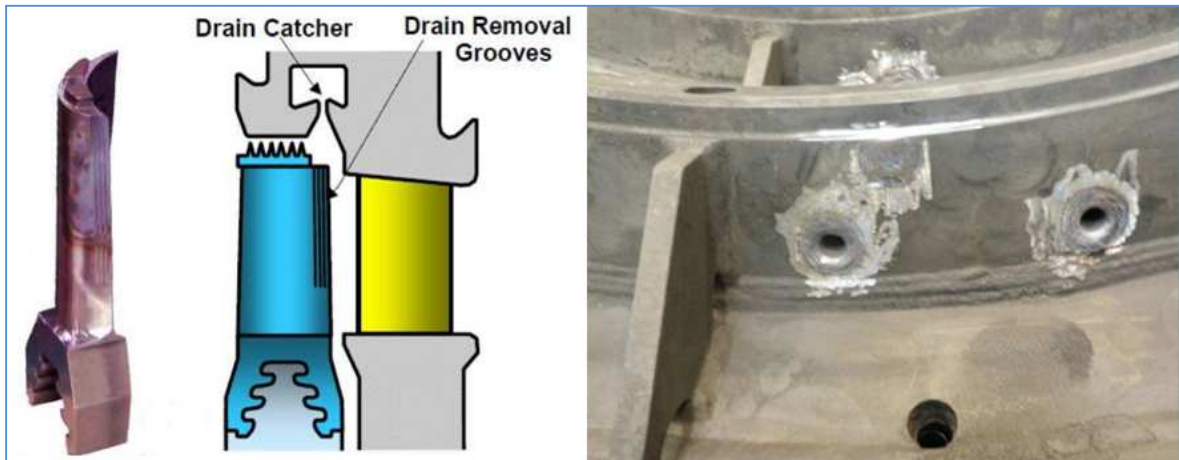
The draining system in the turbine manufactured by Toshiba is different from the one in the turbines manufactured by Mitsubishi. In the high pressure turbines from Mitsubishi there are draining holes in the bottom of the casing in front of the diaphragms. In the low pressure turbine from Toshiba there are drain catchers, which accumulate the droplets in a cell, between the stator and rotor blades. There are also grooves on the backside of the leading edge on the rotor blades, which lead to those cells, that are supposed to catch the droplets in the steam. These two different drain systems can be seen in Figure 4.12. Both systems only transport the moisture in the steam over to the next stage but not out of the turbine. The experience from Hellisheiði power plant is that the draining system designed by Toshiba appears to work better than the one designed by Mitsubishi.

Figure 4.12 Left, illustration of how the draining system in the low pressure turbine manufactured by Toshiba works. Right, example of drain holes in the casing in the high pressure steam turbine manufactured by Mitsubishi [41, 47].

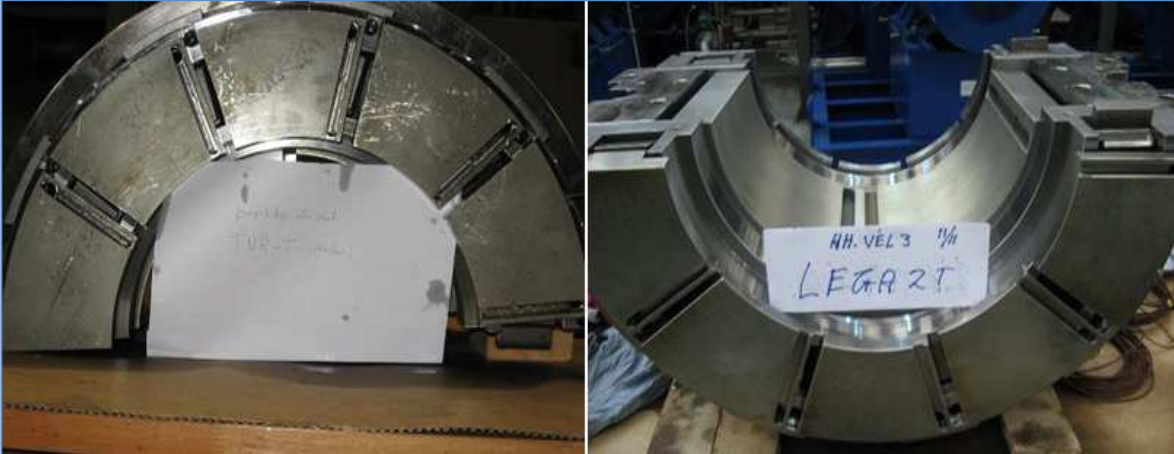
The only problems with the pressure bearings are dirt accumulation and scratches. The main bearings had no visible damages at all. The main bearings had only been in operation for 2.5-4 years before they were inspected during overhauling of the turbines. It was thus to be expected that no wear or damages had occurred yet as this operation time is relatively short for such bearings. A pressure bearing and a main bearing can be seen in Figure 4.20.

Figure 4.20 Left, pressure bearing from turbine 1 at Hellisheiði power plant. Right, one half of a main bearing for turbine 3 at Hellisheiði power plant [41].

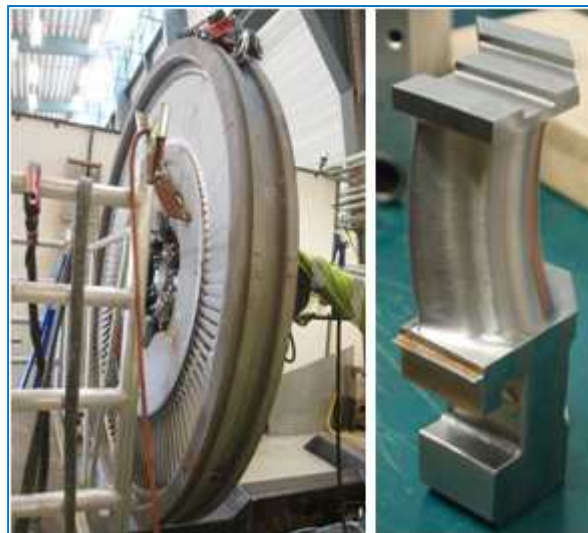
Figure 4.26 *Left, diaphragm from a turbine at Hellisheiði power plant during welding repairs in specially designed equipment. Right, a stator blade for one high pressure steam turbine at Hellisheiði power plant.*

Fractures in stator blades can be repaired with TIG welding with ER309Mo as a filling material. Welding a stator blade on a diaphragm is, however, a demanding work. As described earlier, welding induces stresses because of the high temperature changes involved. Later on, those stresses can cause new fractures to form with possible severe effects. The maintenance staff at Hellisheiði power plant has designed and built a cooling element to cool the stator blades during welding to solve this problem but one method to decrease residual stresses in a welded object is to cool it during welding. The cooling element is made of two units cooled with water. By doing this, both sides of the stator blades can be cooled during welding. This equipment can be seen in Figure 4.25. The wear at the inner and the outer roots at the stator blades can also be repaired with TIG welding with ER309Mo as a filling material. At Hellisheiði power plant this repair is conducted by the maintenance staff at the power plant as well. Orkuveita Reykjavíkur has also designed and built equipment, which can be seen in Figure 4.26, to support and rotate the diaphragms during welding repairs. It is considered that welding the diaphragms with this equipment will cause less distortion. Diaphragms where the stator blades or the roots at the stator blades have been repaired with welding are yet to be installed in a turbine so it is not yet known if those repairs are compatible with original components.

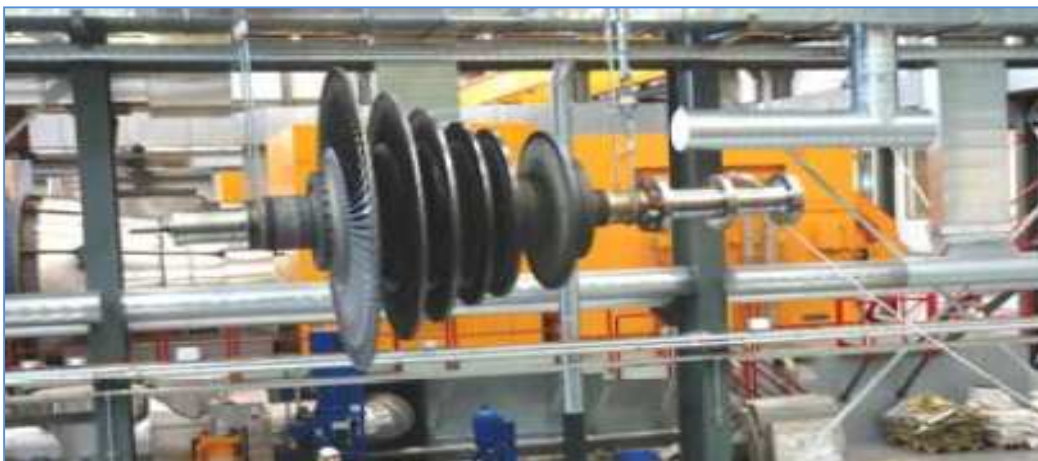
Transporting a rotor from Iceland to a foreign county for repair is time consuming, expensive and introduces the risk of damaging the rotor. This means that damage on a rotor blade like wear on the backside of the leading edge is not repaired during each overhaul. It would both take longer time than the 4 weeks that the overhauling takes and be too expensive. Operators prefer to wait until the wear on a rotor and its blades is considered sufficient enough for the rebuilding of the rotor to be inevitable. This way more repairs can be made on a rotor in one trip to a service company. However, this increases the risk that components like rotor blades either require a considerable repair or can be too worn to repair and need to be replaced for new ones with associated cost. It would thus be more practical to carry out repairs of a rotor and rotor blades on-site or at nearby workshops during the overhauling of a turbine. In this way, small damages like wear in rotor labyrinth seals and rotor blades could be repaired at early stages. This would increase the lifetime of the rotor and its components. Figure 4.28 shows the rotor from steam turbine 2 at Hellisheiði power plant.

Figure 4.28 *The rotor from turbine 2 at Hellisheiði power plant during overhauling of the turbine [41].*

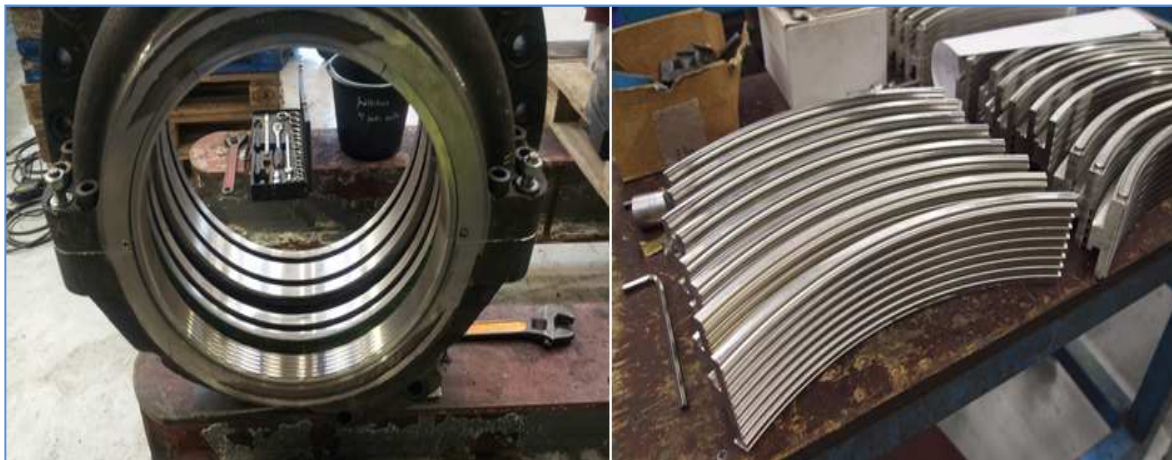
It is hard to repair labyrinth fins as was already explained in the Diaphragms section in Chapter 4.5. Furthermore, the labyrinth fins on the labyrinth packing are not exchangeable like the ones on the diaphragms. The labyrinth packing is made of 6 segments, which can be seen in Figure 4.30 and they can be changed. The segments in the labyrinth packing for the gland seal systems in the steam turbines at Hellisheiði power plant were previously

Figure 4.30 Left, repaired casing with labyrinth packing manufactured by Vélvík ready for installation. Right, new labyrinth seals for a labyrinth packing made by Vélvík ready for installation [41].

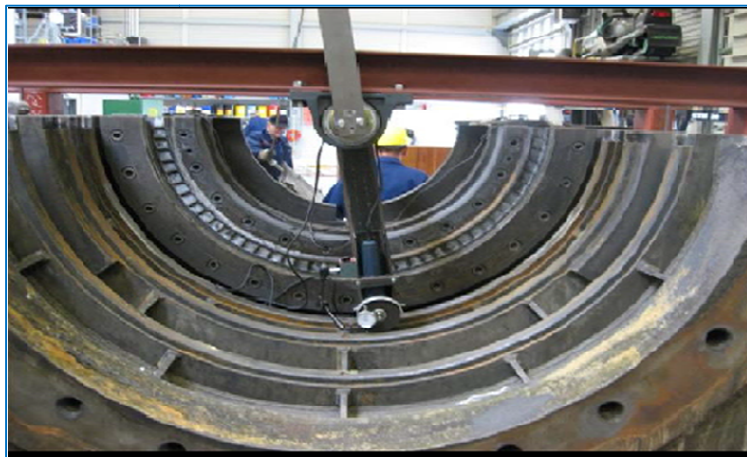
Figure 4.33. Diaphragm attachments in the steam turbines at Nesjavellir power plant that have been polished with this machine have not eroded [10]. Wear at other locations in a casing can either be welded and polished by the maintenance staff at Hellisheiði power plant or repaired with Wencon repair materials by Framtak.

Figure 4.33 *Polishing machine to polish diaphragm attachments in a casing of a steam turbine [41].*

It is mainly one method, which is available for repairing the wear on the attachments for the diaphragms in the steam turbines at Hellisheiði power plant. Weld them with MIG or TIG welding and polish them down to the original shape. This can be made by the maintenance staff at Hellisheiði power plant. In Figure 4.32 a diaphragm attachment before and after such a repair is shown. It is important that a surface on the side of an attachment is flat, else leakage between the diaphragm and the casing is likely to occur, which can cause erosion damage. Previously this work was done by hand but the results were not satisfying because the repaired attachment often eroded. A special polishing machine was thus designed and built by Héðinn to polish the sides of the attachments in the steam turbines at the power plants at Hellisheiði and Nesjavellir. This machine can be seen in
